MICHIGAN BOARD OF BOILER RULES

September 16, 2008

*** A G E N D A ***

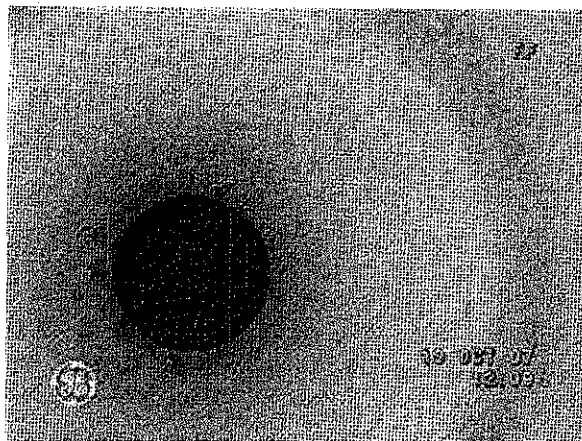
Mud Drum inspections did appear to contain lesser amounts of deposition than previous inspections. Previous inspections noted about 5% of tubes contained partial blockage from chip scale. Today's inspection found only one tube with partial blockage, a sample was obtained for analysis.

Boiler #1 Tube from Steam Drum

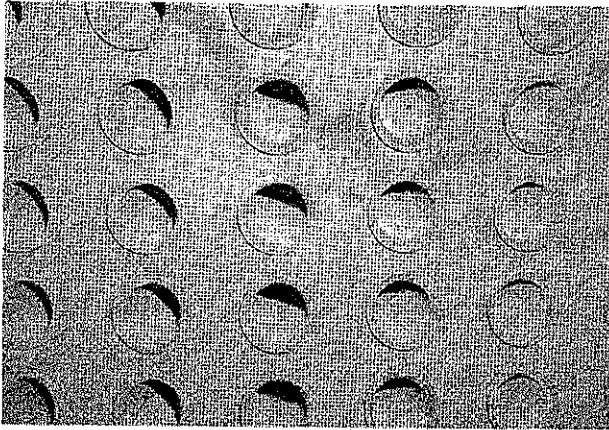
A majority of the tubes (>95%) were clean and free of debris. Did note a few tubes beneath the initial feedwater inlet to have heavier accumulations. Boroscope inspections found these tube deposits to clear further into the tube. We also observed light accumulations around tube throats as enter into the mud drum. We did not observe extensive signs of steam blanketing of poor circulation. We did not observe the partial tube blockage in #2 boiler as we had observed in #1 Boiler.

Boiler #2 Mud drum downcomer

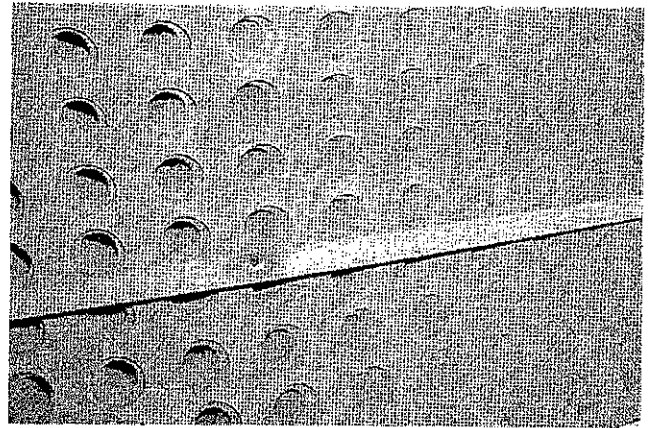
Boiler #2 Steam Drum majority of tubes clean, note PO4 feed line

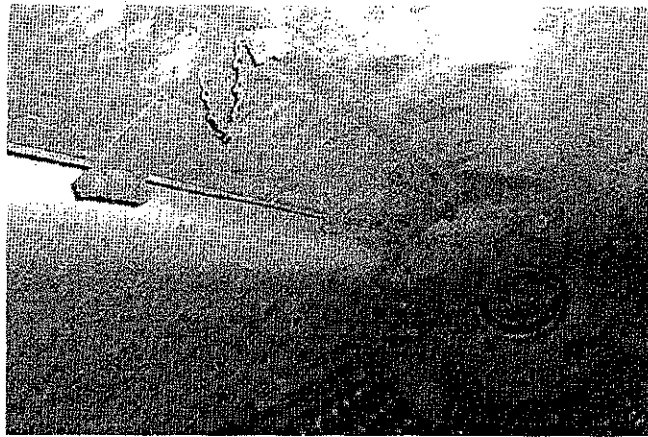
Boiler #3 maintains a greater magnetite (black iron oxide) layer than the high-pressure boilers. I continue to note red iron oxide in the feedwater steam drum particularly along the feedwater tray. This suggests some oxygen intrusion (possibly during storage) however extensive pitting was not observed. Internal cleanliness was considered quite acceptable. Again, no evidence of O₂ corrosion was apparent in the crossover steam drum and mud drum. Water levels at the main steam drum were at appropriate 50% level, however levels in the crossover steam drum were noticeably higher....slightly above the manhole cover. This has been observed in the past. *Recommend reviewing original specifications for proper control of water levels.*

Higher water levels in cross-over (front) drum

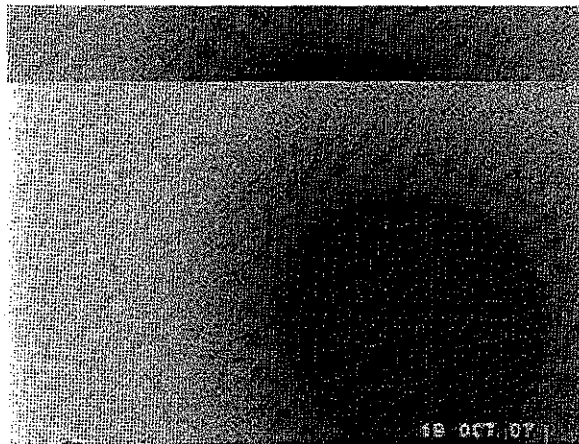
Video boroscope inspections found extremely clean tubes from steam drum through to mud drum. Overall, the internals of boiler #3 was considered quite acceptable. No significant accumulations were observed in the mud drum of #3 boiler as compared to the higher-pressure units.

#3 Boiler Video Boroscope of tubes very clean
